Operation of the Hydrosmart aboard the
roro-vessels Norstream and Norsky

Maritiem Instituut “De Ruyter”
Flushing, The Netherlands

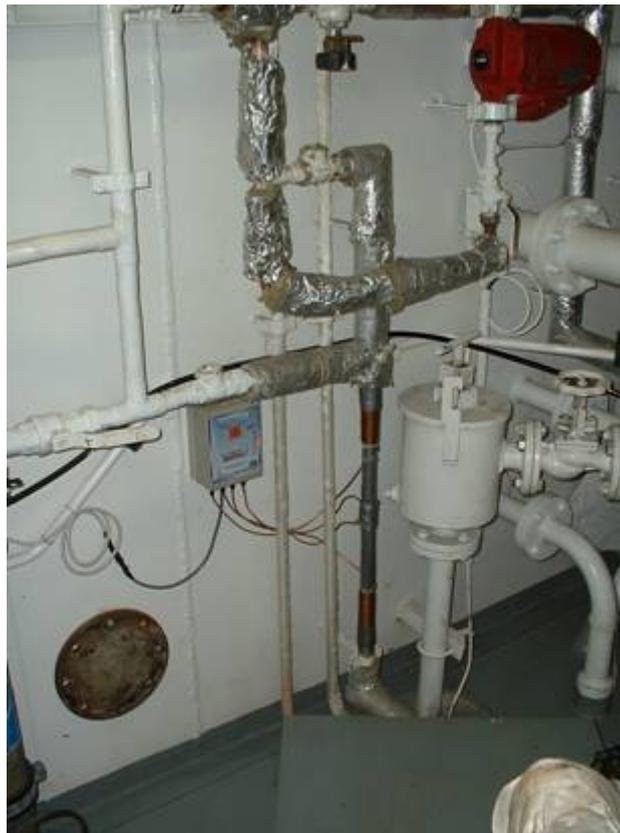
Hydrosmart installed aboard the Norstream

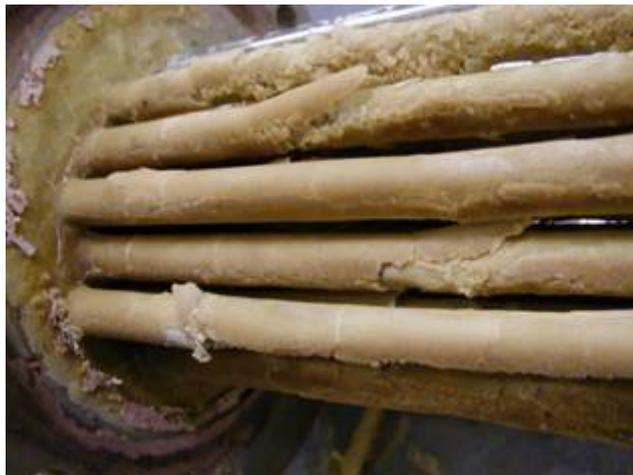
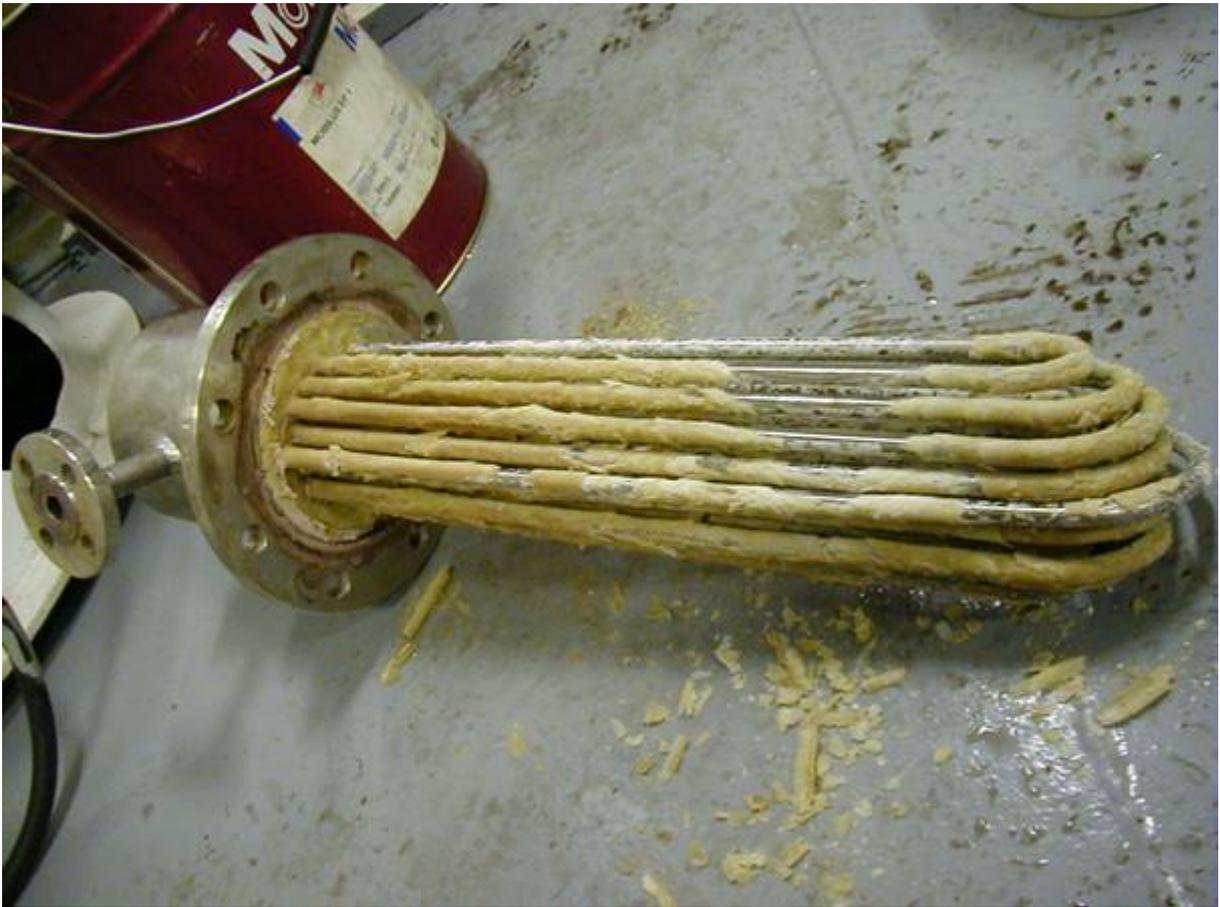
After another month, around the 12th of February 2006, problems occurred with the heater aboard the Norsky. At high loads, the temperature of the hot water fell. The engineers suspected that there was a high build-up of scale on the tube stack. The heater was then opened up and photographs taken of the elements which had scaled up significantly. In the two pictures below you will see the diameter of the scale around the pipes was about 3 mm.

Heat Exchanger aboard the Norsky, 12th of February 2006

Heat exchanger aboard the Norsky, 12th of February 2006

After approximately 3.5 months (12 Feb 2006) the heater on the Norsky was polluted with a high scale build up. At this stage the condition of the Norstream was unknown as it had not yet been opened up for inspection.

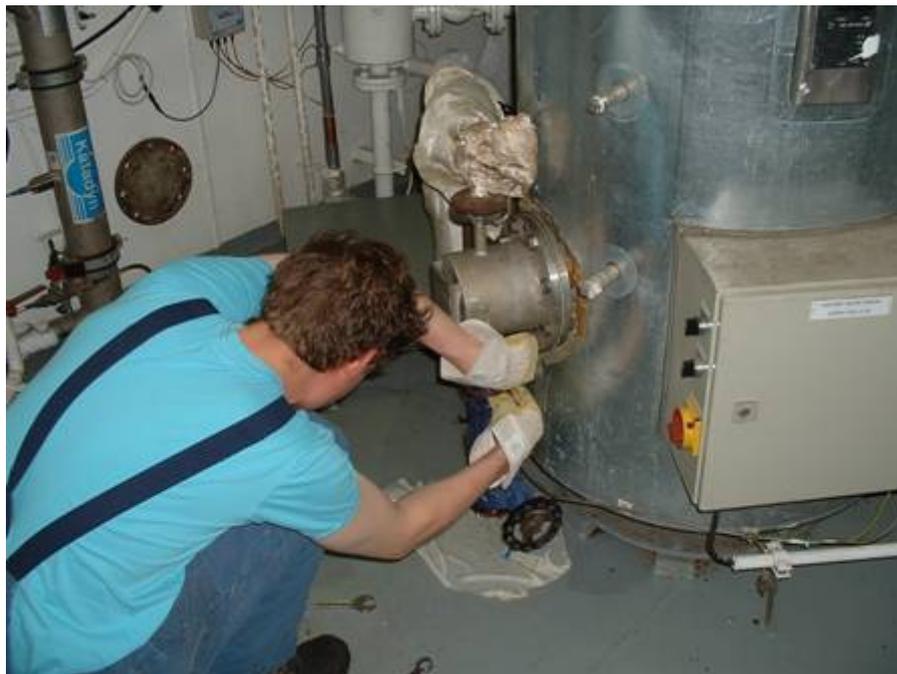
The Norstream was visited in the port of Zeebrugge on Monday 22nd of May 2006. 7 months earlier the heating systems elements using Hydrosmart had been cleaned by the previous project group. With help of Chief Engineer the boiler was shut down, drained and opened up.

Opening of the Heat exchanger aboard the Norstream

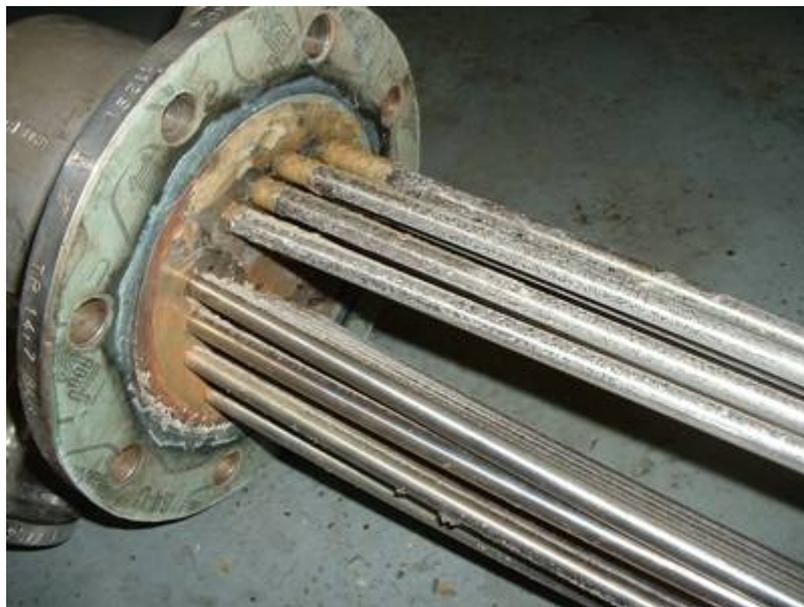
Heat exchanger aboard the Norstream, 22nd of May 2006

It was observed that only on the side where the steam comes in there was some minor scale, the rest of the heat exchanger showed no build up on any of its surfaces.

After 3.5 months the exchanger running without Hydrosmart treatment was polluted with significant scale build up. When the heat exchanger on the Norstream was opened after 7 months, hardly any visible scale could be seen.

We can therefore conclude that the Hydrosmart treatment extends the time between cleaning of heat exchangers on these vessels and lowers maintenance problems very certainly.

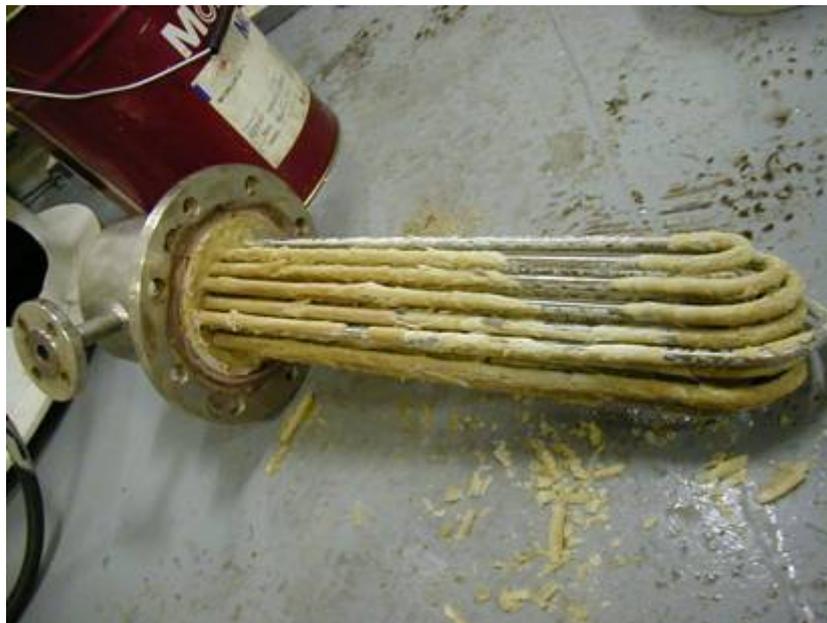
Heat exchanger aboard the Norsky, 12 February 2006

The difference in scale on both exchangers is to be seen clearly on the photographs provided. The exchangers were both cleaned in the same week to commence this trial, providing identical situations at trials commencement. The bunkering with mains water at each port was not controllable, but it is assumed the water quality was of the same source of supply in both vessels at the time of bunkering. Considering the ships are of the same type and on the same shipping lane we assume this to be consistent to both vessels.
